Application for Variance

The purpose of this document is to explain the details associated with the current status of the property located in 10230 111TH AVE NE, Kirkland WA 98033.

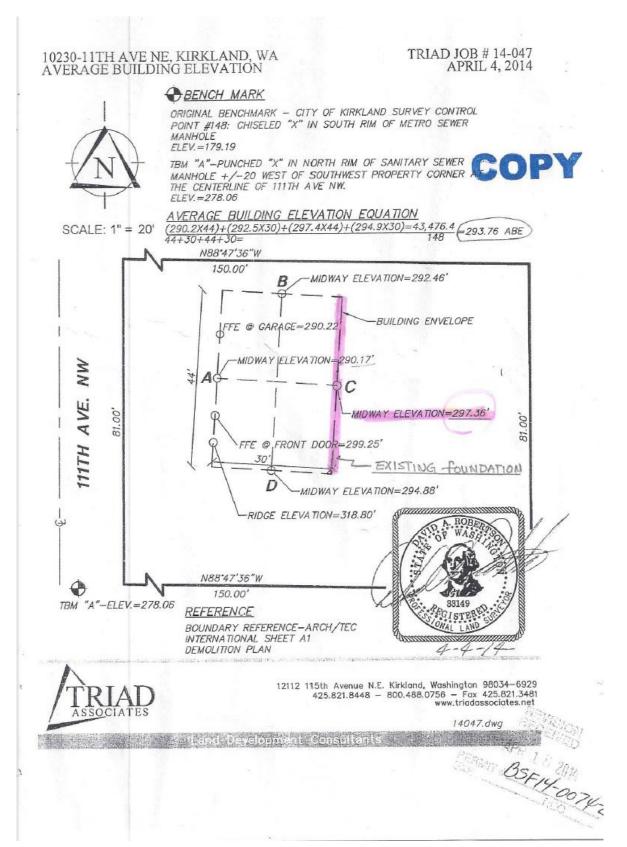
The above document is to show that during the planning stage of the CHOI project, the 1st elevation survey was conducted on **EXISTING** foundation. Based on the existing foundation the average building elevation was calculated as 293.76 ft ABE.

- 1. The property was built with "major remodel" initiative as we wanted to use the existing foundation to save the cost associated with CHOI residence major remodeling project.
- 2. From the above image, the pink highlighted line shows that elevation of the Ground level on the east side of the property is calculated as 297.36 ft (approximately 4ft higher than the average elevation ABE). This will prove to be key information towards the end of the document.
- 3. From reviewing below image, you will be able to see the foundation addition towards the east side from the yellow highlighted line.

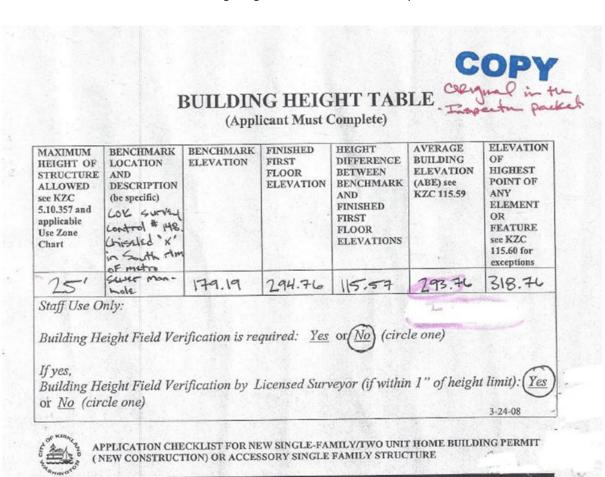
Now, because the original elevation survey yielded an Average Elevation of 293.76 ft ABE, the City of Kirkland provided the below document for the contractor to reference to.

- 1. Average Building Elevation (ABE) is 293.76 ft
- 2. Maximum height of the structure allowed is 25 ft
- 3. Elevation of highest point is 318.76 ft
- 4. It is interesting to note that Under "Staff use only" section, City of Kirkland personnel circled "No" in the section where it states "Building Height Field verification is required".

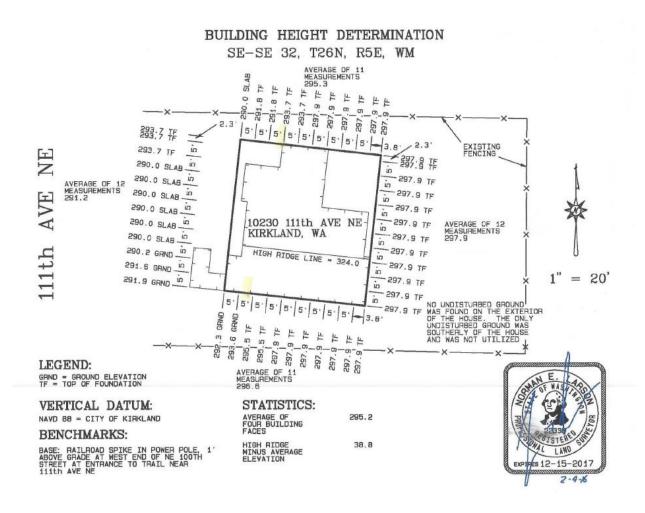
Please refer to below document which was the 2nd Elevation survey we conducted after the property construction was completed.

It shows that the highest ridge line of the property was found to be 324.0 ft.

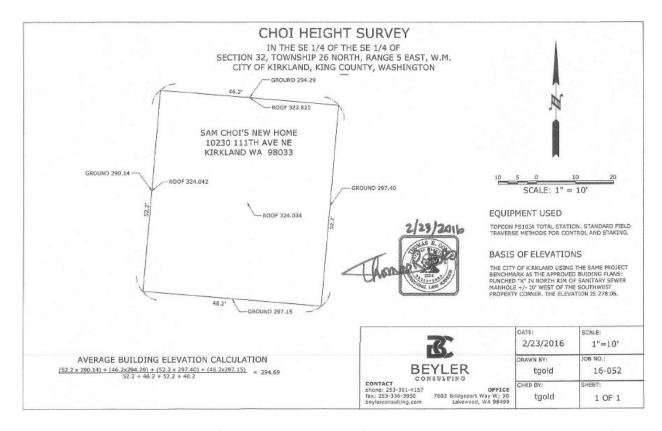
The result of the 3rd elevation survey that was conducted on 2/23/16 is as follows: (Please see below image)

- 1. The average building elevation was concluded as 294.69 ft. This is 0.93ft higher than the 1st elevation survey average.
- The east side of the ground was concluded as 297.40 ft.
 This is consistent with the 1st survey (297.36ft GRND) and somewhat consistent with 2nd survey (297.9ft TF).
- 3. The roof ridgeline was concluded as 324.04 ft (consistent with 2nd survey)

With the conclusion that top roof ridge line being 324.04ft and the average elevation being 294.69ft, this meant that the structure was 29.35 ft in height, 4.35ft higher than maximum allowed. At this stage, we knew the issue wasn't related to average elevation anymore and this is when my contractor and I decided to review all the data from the beginning of the project as we were confident that there was NO WAY that we would have built a property that was 4.35ft higher than allowed.

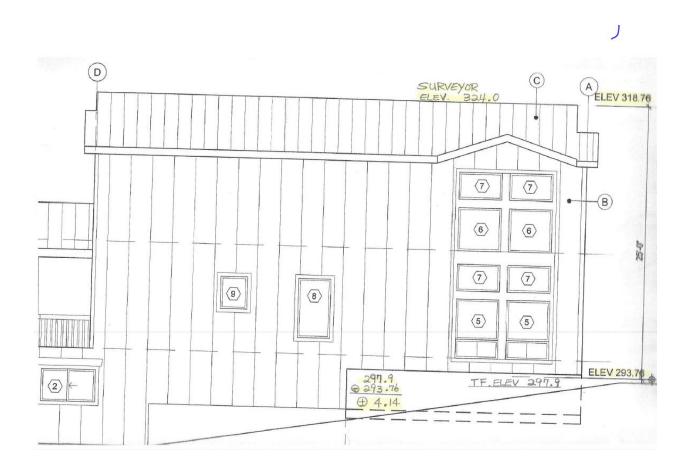
Fortunately, my contactor and I were able to come up with critical data that starts to explain the 4.35ft gap. Let's take a look at the planning drawing (shown below) that my architect prepared during planning stage which was approved/permitted by City of Kirkland planning department

On the right side of the diagram (where the east and south end of the property meet), it shows the elevation as 293.76ft and when you add 25ft of max. height, you reach the 318.76ft shown on the top right hand corner.

However 293.76ft shown on the diagram is incorrect. We are able to see that the corner where East and South end meet is not 293.76ft but 297.9ft TF (from 2nd elevation survey) or 297.40ft GRND (from 3rd elevation survey). Therefore 293.76ft stated on the drawing is 4.14ft lower than what the elevation is supposed to be and the drawing should have reflected 297.90ft TF.

- 3. However, the discrepancy in the planning drawing (explained on Page 7-8) shows that there was an error of 4.14ft which roughly explains why the property was built approximately 4.35ft higher than allowed.

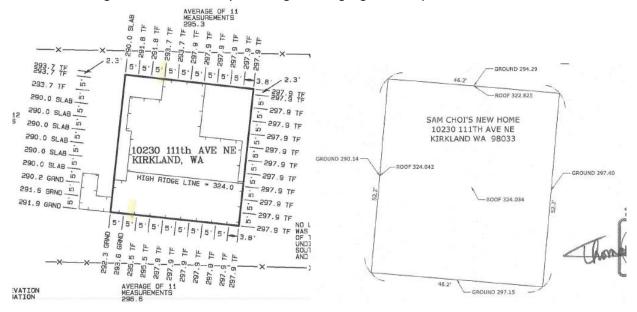
I am referencing the elevation surveys once again to highlight the importance of this corner.

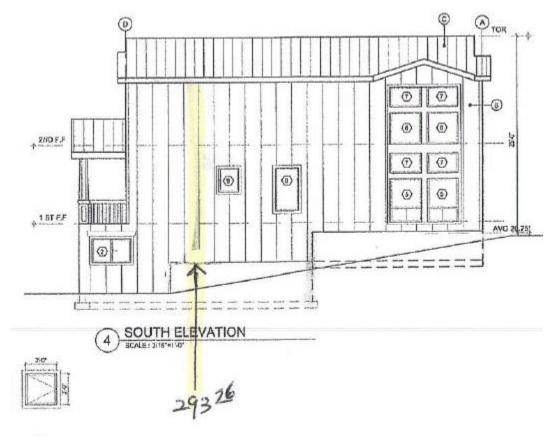
So then, where exactly is 293.76ft 2 294.69ft elevation level? We believe 293.76ft 2 294.69ft elevation level is extremely close to where you see the yellow highlight in the below image. Had my architect and City of Kirkland catch this error during planning stage, we would not have built a property that has a 1st floor of 8 ft in height and 2nd floor of 7 ft in height and would have re-designed the property.

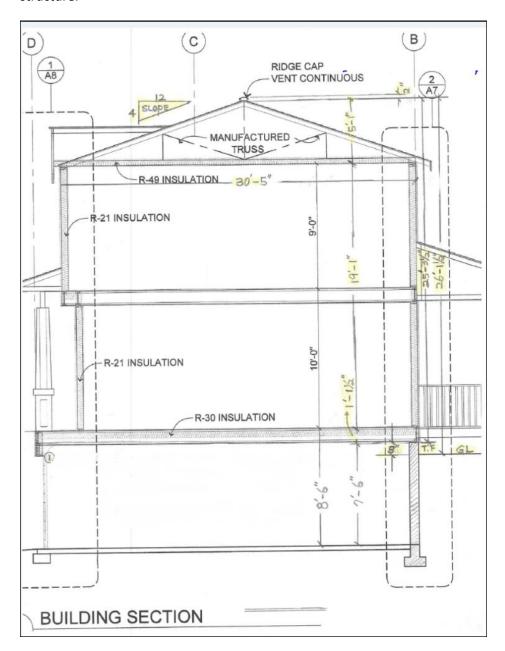
Let's now review the vertical view of the planning diagram which helps us understand the height of the structure.

Important items to consider in this diagram are as follows:

- 1. From the ground level of the garage to the top of the garage door was measured at exactly 7 feet.
- 2. From the ground level of the garage (on the rear side of the garage) to the top of the ceiling was measured at 7 feet 6 inches.
- 3. R-30 insulation between the garage and 1st floor is 1ft and 1.5inches.
- 4. The elevation delta between the Top of Foundation (TF) and Ground is approximately 8 inches.
- 5. From the 1st floor to 2nd floor is 10ft

- 6. From 2nd floor to bottom of the truss is 9ft.
- 7. The truss height is 5ft 1inch and the ridge cap is additional2 inches.
- 8. Let's add all the variables here.
 - From the top of the foundation as the reference point
 - 13.5 inches [insulation/flooring] + 120 inches [1st floor] + 108 inches [2nd floor] + 61 inches [truss]
 - + 2 inches [ridge cap] results in 304.5 inches or 25.38ft.
- 9. This validates that the height of the property is closer to 25ft, not 4.35ft higher than originally anticipated from the elevation surveys.

- 5. Before the permit was granted, this error (shown on Page 8) should have been corrected in order to avoid such situations.
- 6. The calculation on Page 9 and 10 shows that the building height is 25.38ft from the TF reference point. This is 0.38ft higher than the proposed maximum height of 25ft however we believe that this delta should fall within the margin of error.

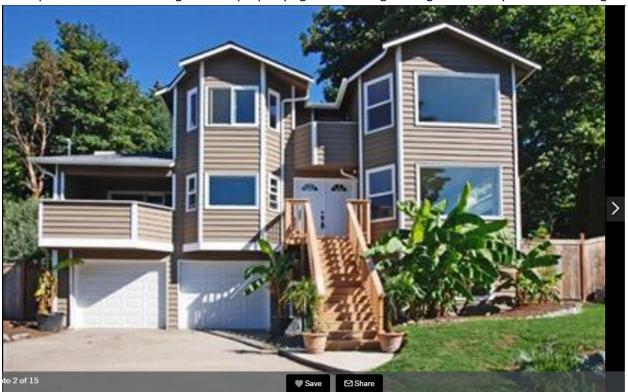
Please take a look at the image of the old structure that was built on 1986.

It's important to note the height of the property against the neighboring fence that you see on the right.

While this is not the most scientific way to compare the height of the 2 properties, it seems from the picture that the height of the OLD and NEW structure is similar for following reasons:

- A. Garage level is maintained as the lower level
- B. The new structure maintains the similar height of the 1st and 2nd floor
- C. The roof designs on the OLD and NEW both have similar styling (slanted design).

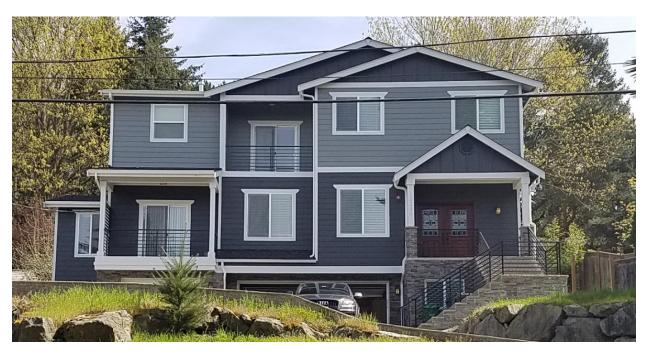
Let's take a look at the new structure and once again, let's reference the fence on the right hand side of the picture.
